21 Report on
OPERATION REDWING—PROJECT 2.4 [U].

6 DECONTAMINATION and PROTECTION (U), 8

10 by J. C. Maloney
and M. A. Schmoke,

April 1957

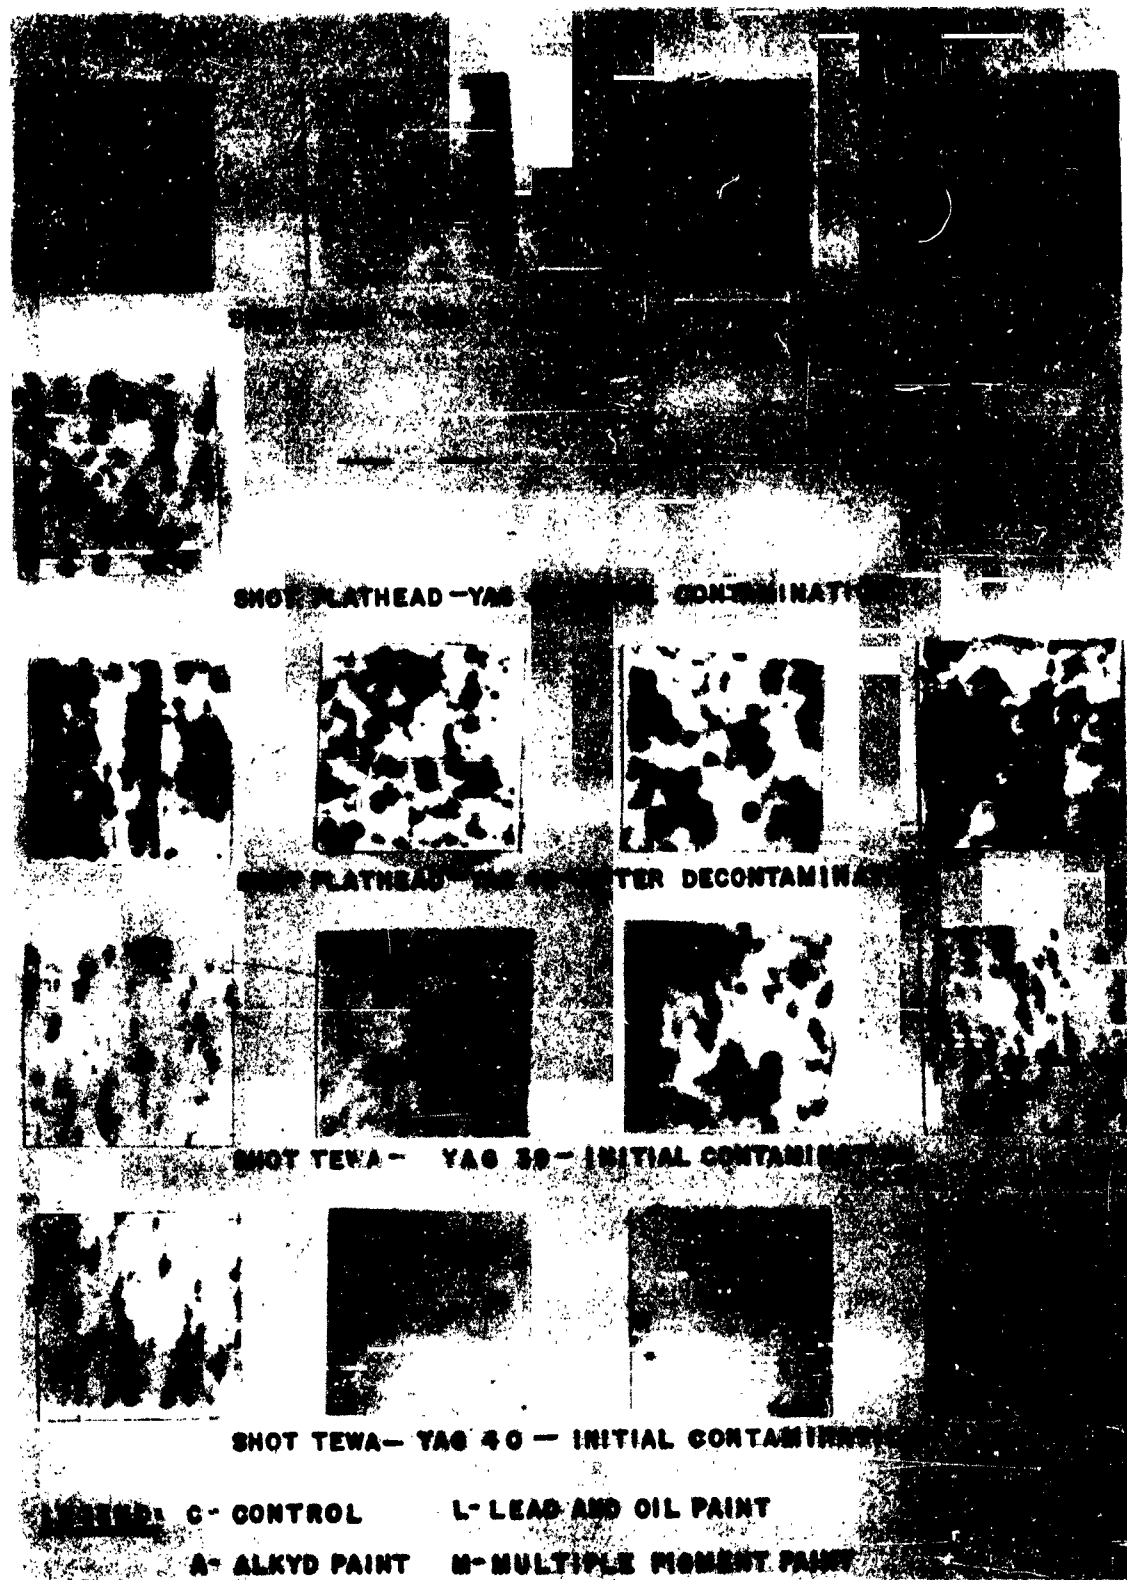
Figure 2 Radioautographs of wood samples.

Physical and Chemical Investigations of Surfaces. Radiophysical Studies. Figure 2 shows the radioautographs of the wood samples taken from panels after various shots. Note that the samples of Shot Zuni show a fine speckled effect, as if fine particulate matter had impinged on the surface. This may well have been what actually happened, since a fine white particulate contamination was found all over the YAG-40 after this shot. Note also that the painted wood samples for Shot Zuni all have a general uniform darkening on the right edge of the sample. This darkening corresponded to a blackening on the original sample, caused by the beating of the black canvas covers on the panel frame. The

black resinous impregnation in the canvas soiled the clapboard edges of all the painted wood panels, and evidently held the contamination to the panel surface. Decontamination procedures did not remove this contamination.

The contamination on the Shot Flathead samples shows up somewhat differently. Unfortunately, radioautographs of the painted-wood samples before decontamination were not taken. However, the control samples show the same general contamination distribution found on the painted-wood samples. It can be seen that the contamination still has a speckled effect, but of much larger spots, or more of a polka-dot effect. This is believed to be due to a liquid-raindrop type of contamination in Shot Flathead, rather than the fine particulates of Shot Zuni. The radioautographs of the decontaminated Shot Flathead samples show a splotchy effect, with slight darkening in the background. This seems to indicate that the decontamination methods actually caused the residual contamination to permeate the wood, producing the splotchy effect seen.

Radiophysical Studies. To determine the manner of distribution of the contamination in the various wooden surfaces, small board strips were removed from each type of wood surface. These were cut into one-inch squares. Three samples of each of the four types of wood surfaces were placed on a photographic plate and radioautographs obtained for each type surface. Figure 2 shows prints of the radioautographs from the various shots.

graphs all represent the distribution of the initial contamination. It should be recalled, however, that these panels had been subjected to heavy rainfall. One sees in these radio-autographs a particulate effect intermediate between the fine speckled effect of Shot Zuni and the polka-dot effect of Shot Flathead. Actually, after Shot Tewa, so little contamination stuck to the panel rack that about the highest reading taken on any panel was about twice the high island background. The samples from the YAG-39 were lightly contaminated, while those from the YAG-40, except the control samples, were so cold that even after a week's exposure, the shading on the photographic plate was still very slight. The spotty effect was apparent, however, although very faint.
